Dentistry Clinical

Aesthetic zone needing augmentation

A case study in which Dr Shushil Dattani replaces a tooth with an implant-supported crown

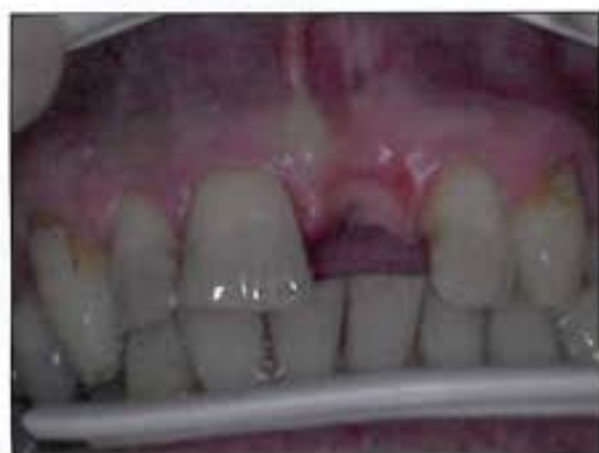
Figure 1: Frontal view showing height and width defect

The buccal defect is apparent in the clinical photos. An implant without bone grafting would produce an incorrect emergence profile leading to an aesthetic compromise. There was a buccal defect apparent. The history of the tooth was a trauma incident (with a cricket bat) which led to the tooth fracturing, needing endodontic treatment around 30 years ago. The tooth subsequently needed an apicectomy. The apicected site was apparent with a soft tissue area apical of the previous tooth. Also, a buccal defect was present 12mm from the edge of the ridge. Ridge mapping clearly indicated a bony defect of at least 12mm in height.

Soft tissue analysis shows 8mm of defect at the edge of the ridge, narrowing to the shape of the previous tooth. There seemed to be a height defect buccally compared to palatally of around 2mm.

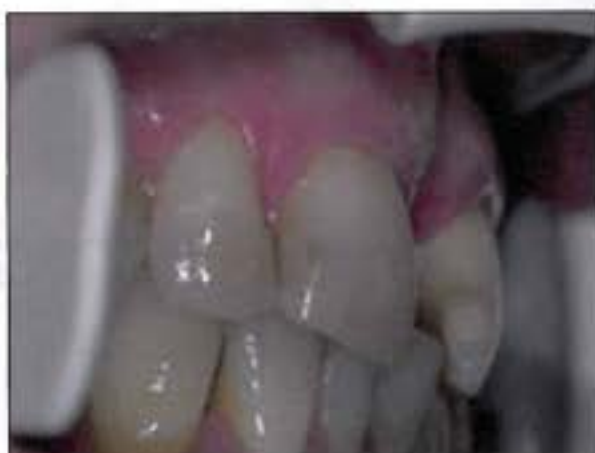
Figure 2: Right lateral view showing width defect

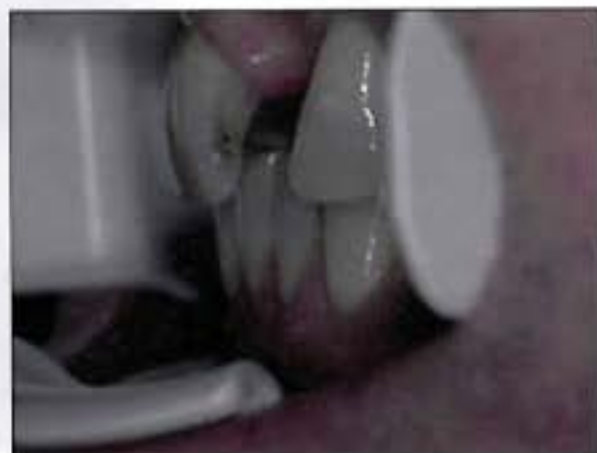
Figure 3: Left lateral view showing width defect

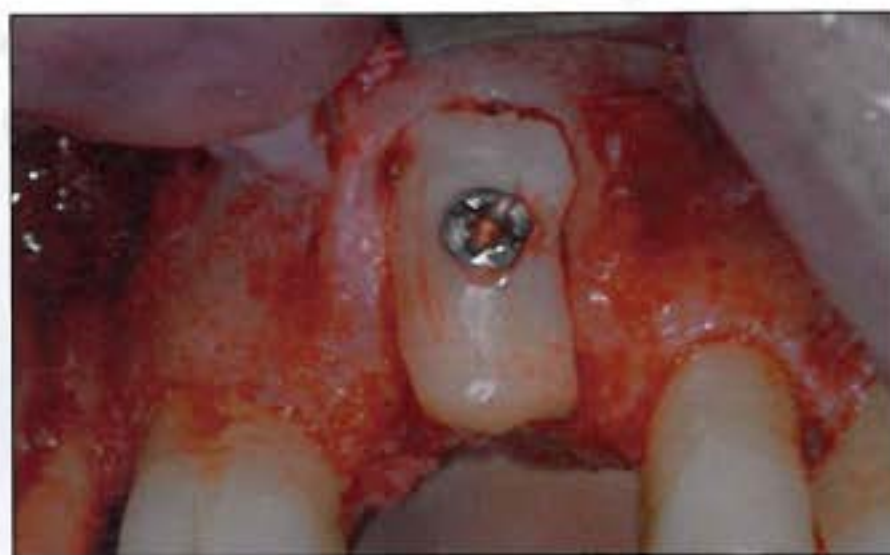
Figure 4: Frontal block graft obtained from ramus in position

Therefore, augmentation was the proposed option. This could be either guided tissue regeneration with the use of bovine/irradiated bone or grafting procedures using intra-oral donor sites. The defect was of height and width, and a J-shaped bone graft would be of more use; therefore, the ideal site for a donor would be the ramus. As the patient is missing both his wisdom teeth, either side could be considered. As the ID canal was more clearly visible on the OPG – and identifiable throughout on the right-hand side – the right ramus was the more ideal site. A ramus graft was obtained from the right ramus as planned and positioned in the upper left central incisor area. Three months were

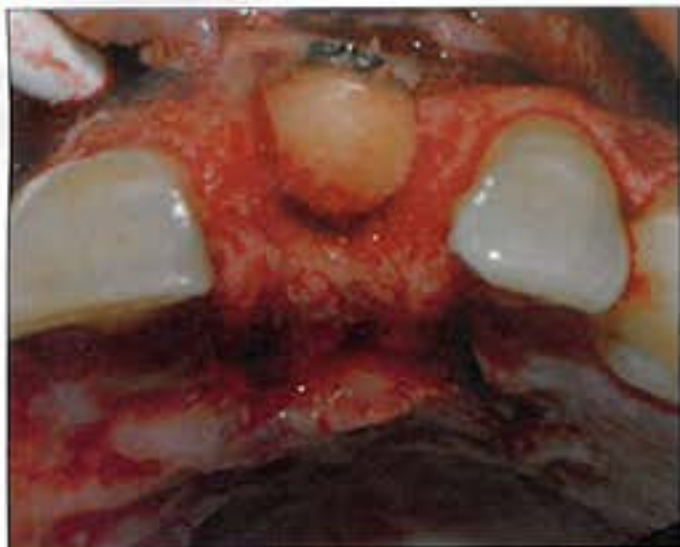
Figure 5: Occlusal block graft obtained from ramus in position

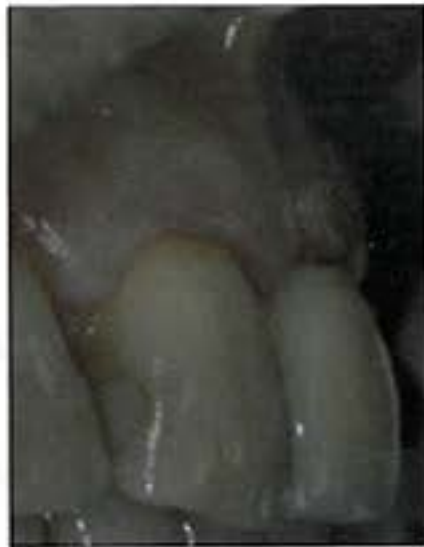
Figure 6: Right view showing definitive restoration showing correction in height and width, and an aesthetic gingival height

The already-chosen abutment the correct angle (22.5 degrees) was fitted and an already constructed temporary acrylic crown was fitted. The crown was adjusted at the gingival margins so to define the final contouring of the gingivae. The final restoration was fitted after three weeks of gingival healing.

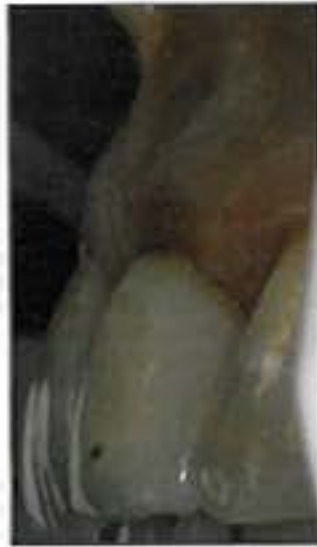
Figure 7: Left view showing definitive restoration showing correction in height and width, and an aesthetic gingival height

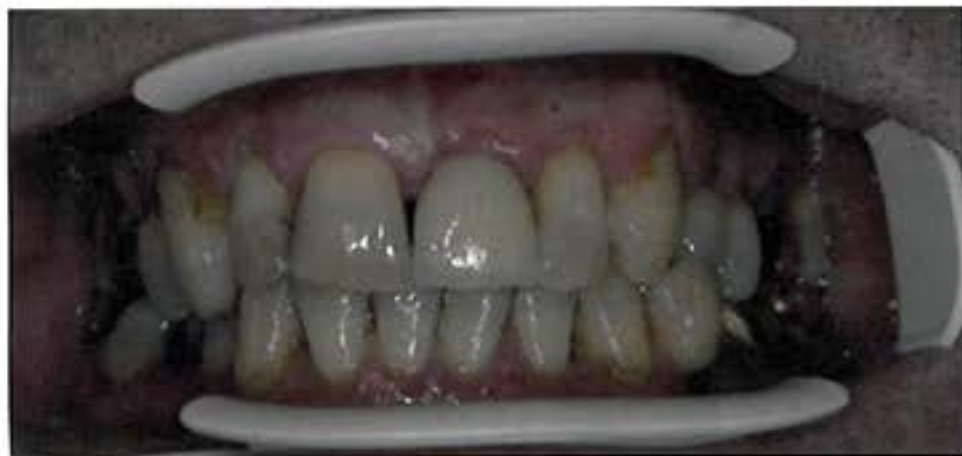
Figure 8: Frontal view showing definitive restoration showing correction in height and width, and an aesthetic gingival height
